Predicting Effects of Sediment Diversions using Existing Landscape Analogs in Coastal Louisiana

Dr. Jenneke M. Visser
School of Geoscience
Institute for Coastal Ecology and Engineering

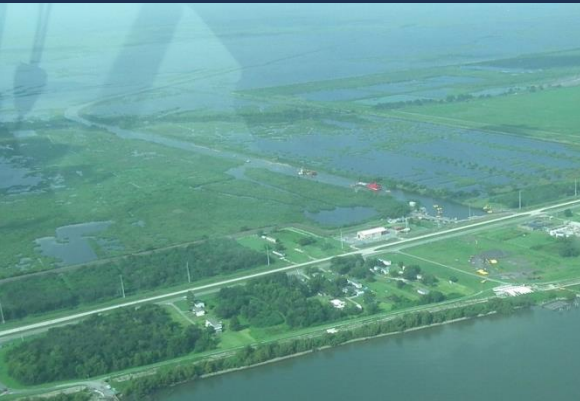
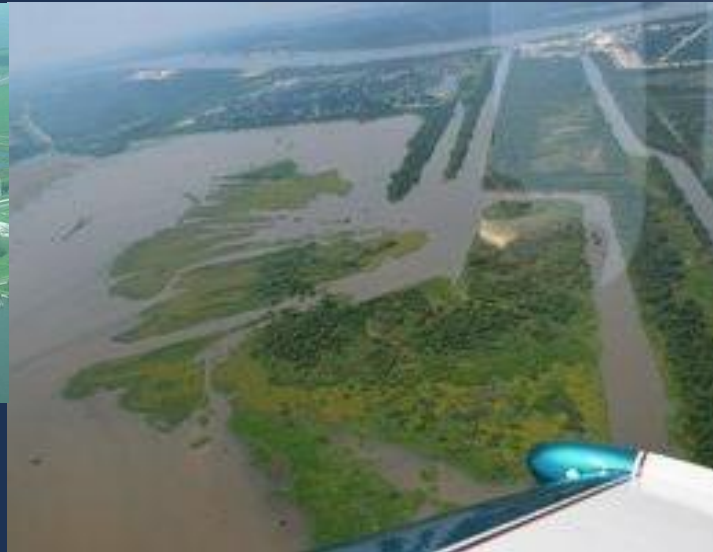
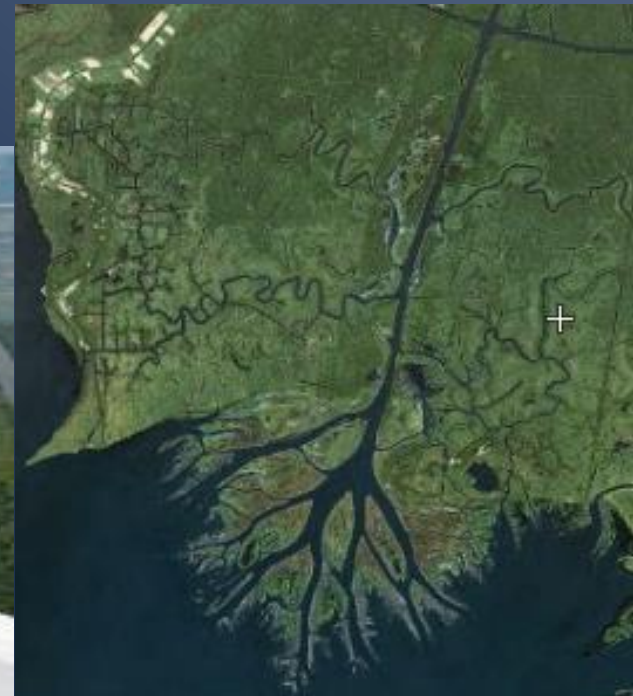
Freshwater vs Sediment Diversions

- Siphons
 - West Pointe ala Hache
 - Naomi
- Max 1,200 cfs
- Gated Structures
 - Caernarvon
 - Davis Pond
- Max 8,000 cfs
- Sediment Diversions
 - Wax Lake
 - Bohemia Spillway
- >20,000 cfs

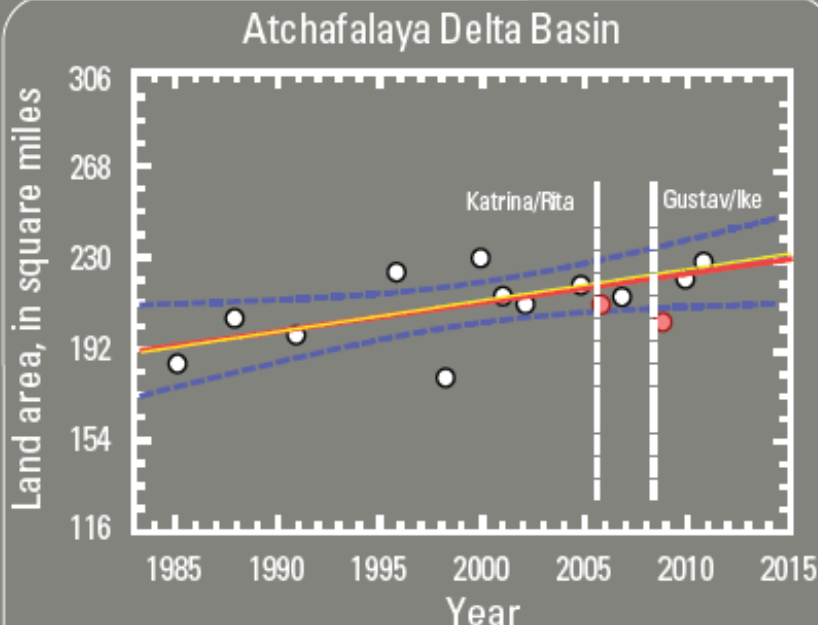
Atchafalaya Delta Basin

1985–2004 = 1.32 ± 0.81 mi²/year ($r^2 = 0.2758$)
 1985–2010 = 1.22 ± 0.48 mi²/year ($r^2 = 0.3909$)

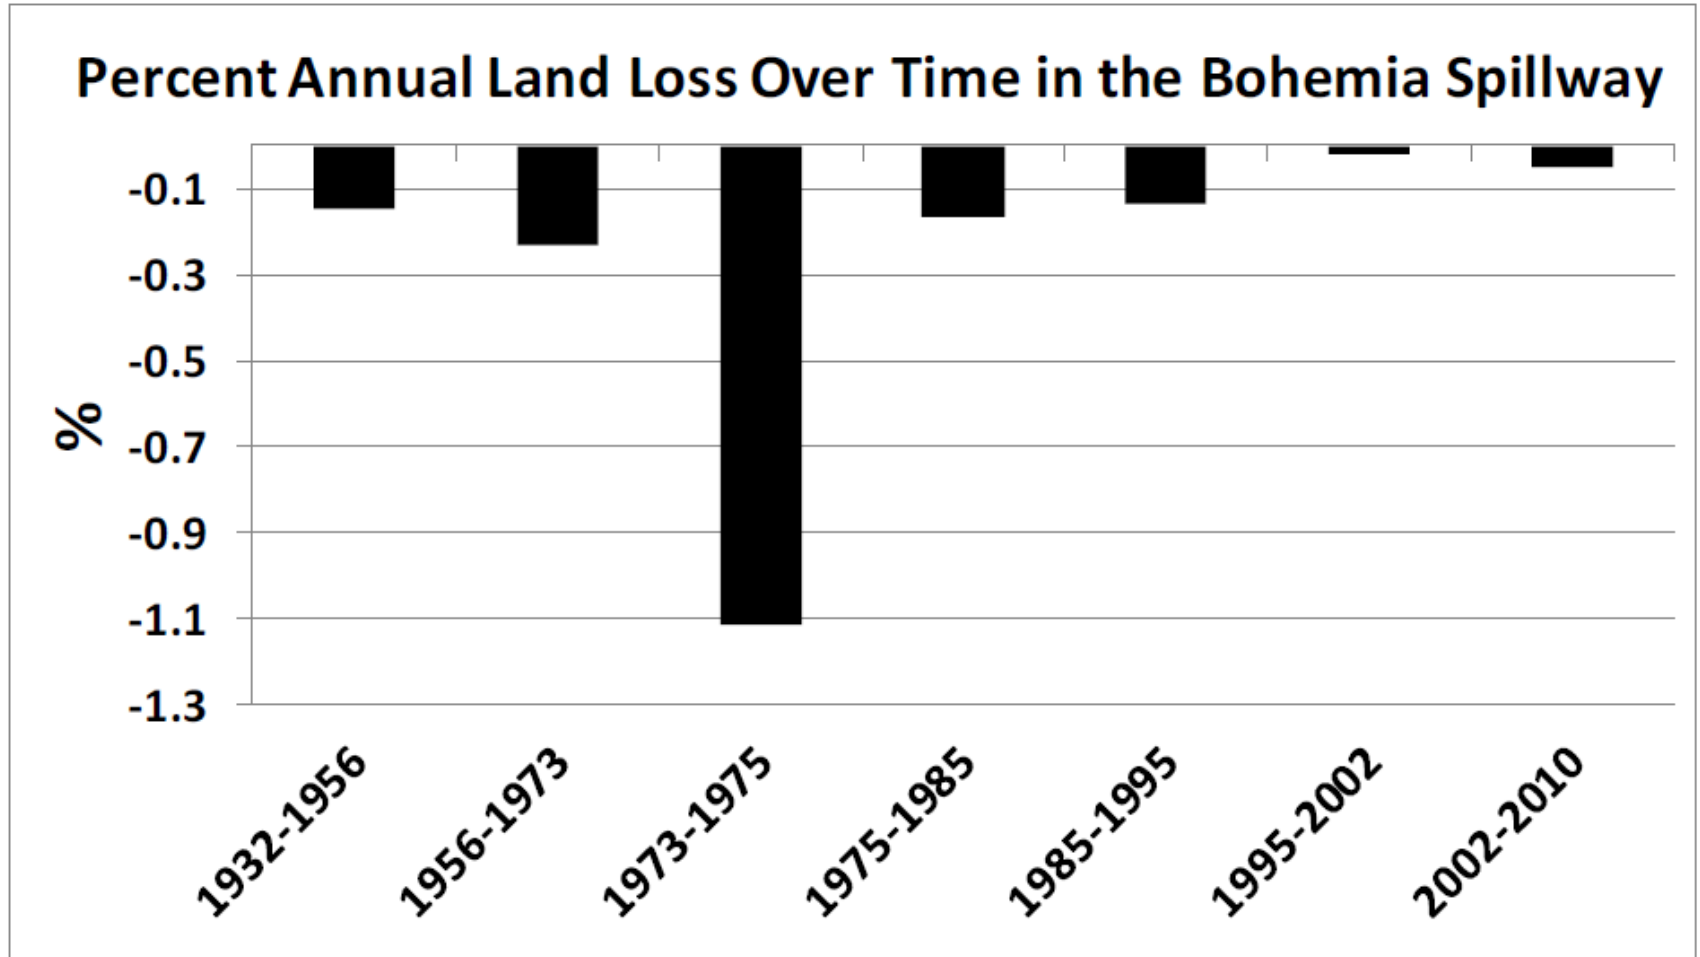
Landloss Bohemia Spill way

Figure 63: Percent annual land loss in the Bohemia Spillway over time using the hybrid data set (USACE and USGS estimates of land loss). Most land loss occurred from 1932 to 1973, due mostly to the construction of canals for the oil and gas industry.
